Supplementary figure to the article "Sonic anemometry measurements to determine airflow patterns in multi-tunnel greenhouse", by A. López, D. L. Valera, F. D. Molina-Aiz and A. Peña. Spanish Journal of Agricultural Research Vol. 10 No. 3, September 2012 (http://dx.doi.org/10.5424/sjar/2012103-660-11)

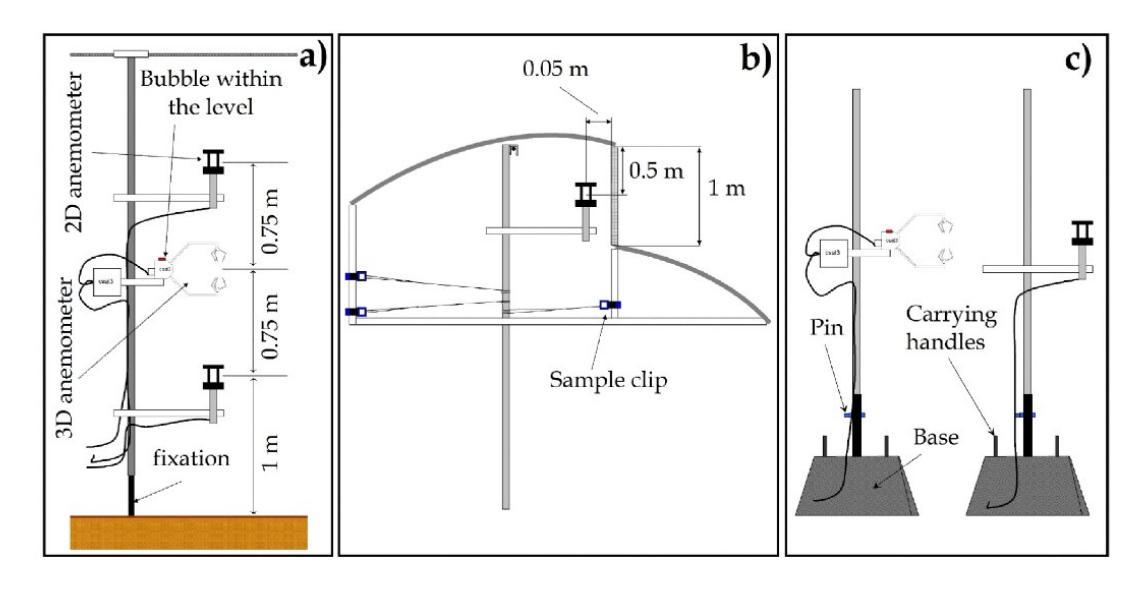
Supplementary Figure 1. Placement of the anemometers inside the greenhouse (a), at the roof vent (b) and outside the greenhouse (c).

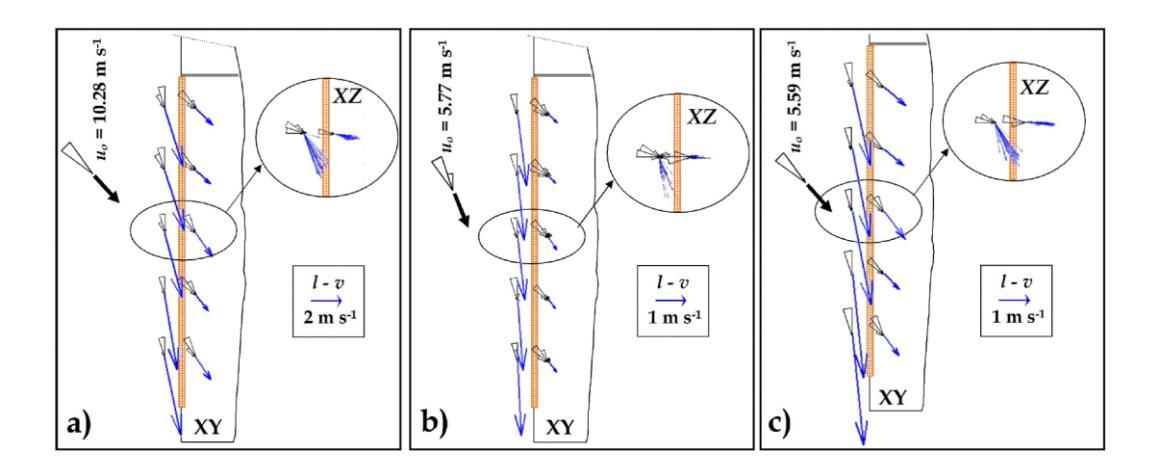
Supplementary Figure 2. Airflow diagram at the outside and inside surfaces of the northern side vent when facing windward. Experiments 4 (a), 6 (b) and 7 (c).

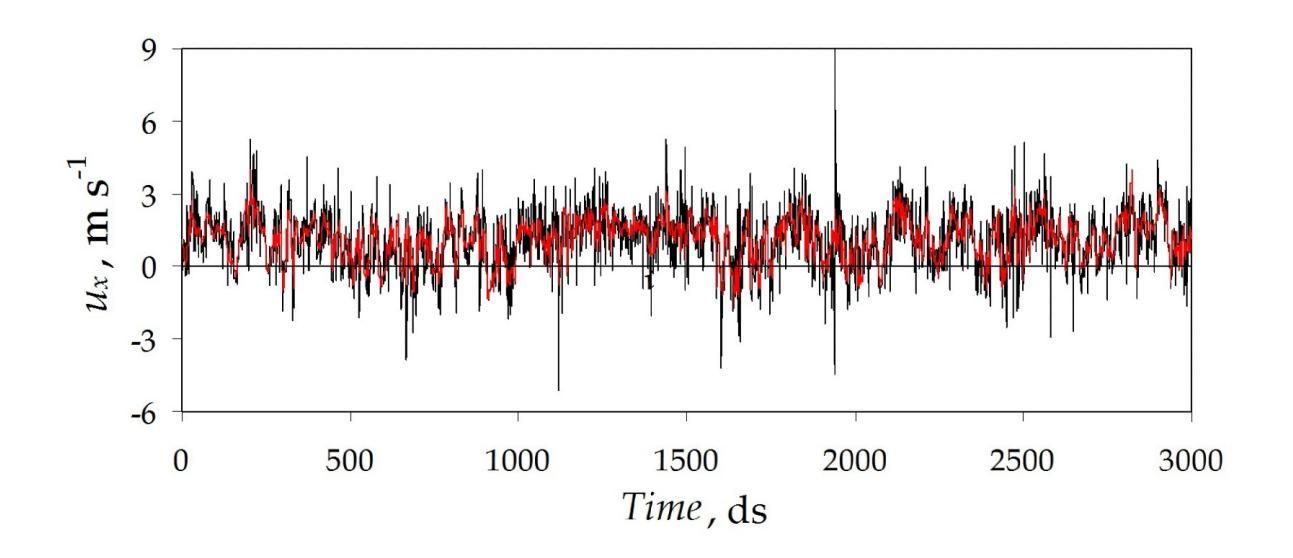
Supplementary Figure 3. Measurement using 3D sonic anemometers of the longitudinal component u_x over five minutes at the windward side vent. Experiment 2, inside surface of the vent (—); outside surface of the vent (—).
